Coal Mine Fatal Accident 2003-28

Roblee Coal Company
Hacker's Creek Mine No. 1
October 24, 2003
Fall of Roof
District 3, Buckhannon, WV
Underground
21
650 tons/day

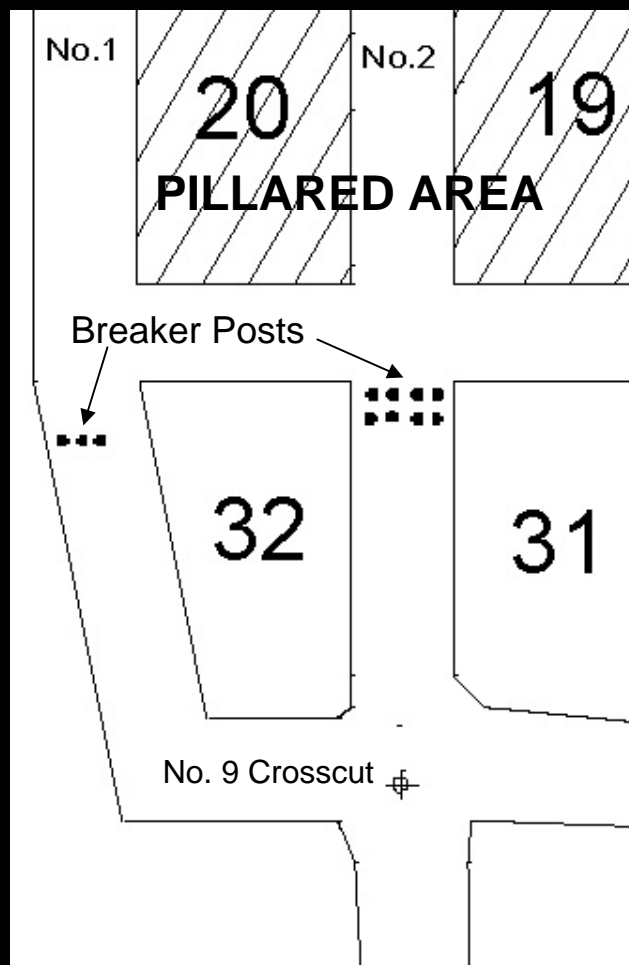
- Between 10:00 and 10:15 a.m., the mining machine was backed outby the pillar line after completing Block 20 and was being moved toward the right side of the section.
- A utility man and an electrician set three breaker posts in the No. 1 entry just outby the No. 20 block, when the roof began to work and fall behind the gob curtain in the No. 2 entry.
- The electrician looked behind the gob curtain in the No. 2 entry and observed that the fall had knocked out the inby row of breaker posts. He then rejoined the utilityman at the intersection of the No. 2 entry and the No. 9 crosscut.

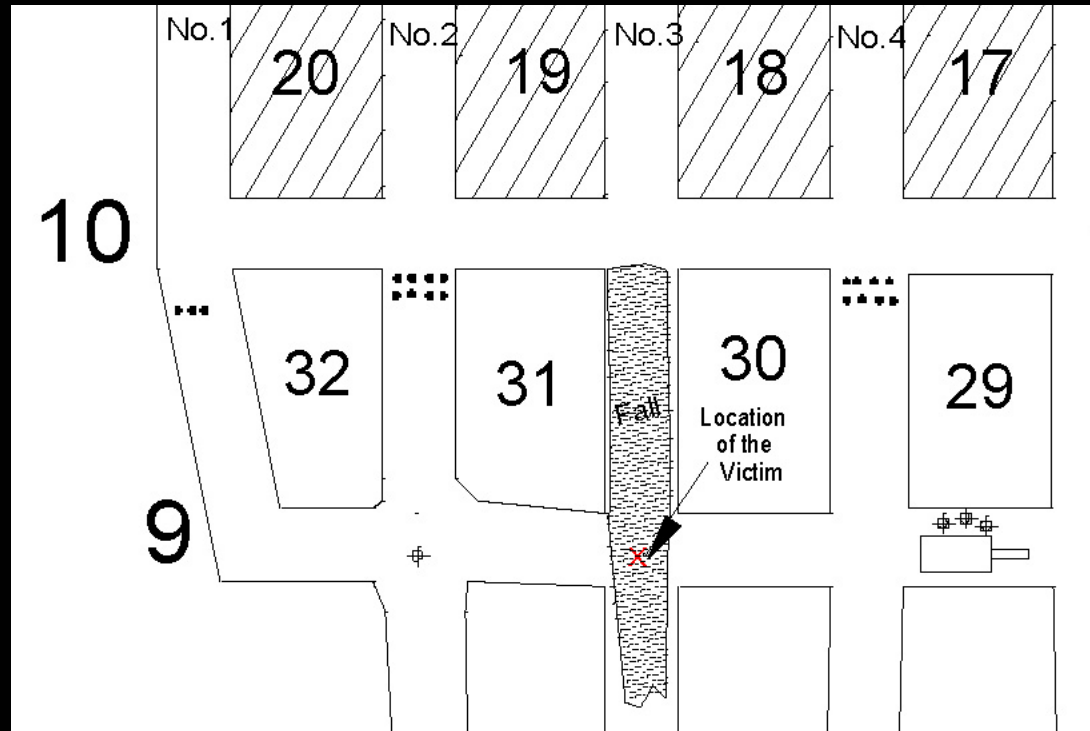
- As the roof began to work again, the utilityman ran toward the mining machine and other crewmembers on the right side of the section through the No. 9 crosscut.
- As the utilityman reached the No. 3 entry, he was struck by a roof fall that extended 1½ crosscut from the pillared area.
- Crew members yelled for the victim, but there was no response. The victim was recovered at 8:15 p.m.

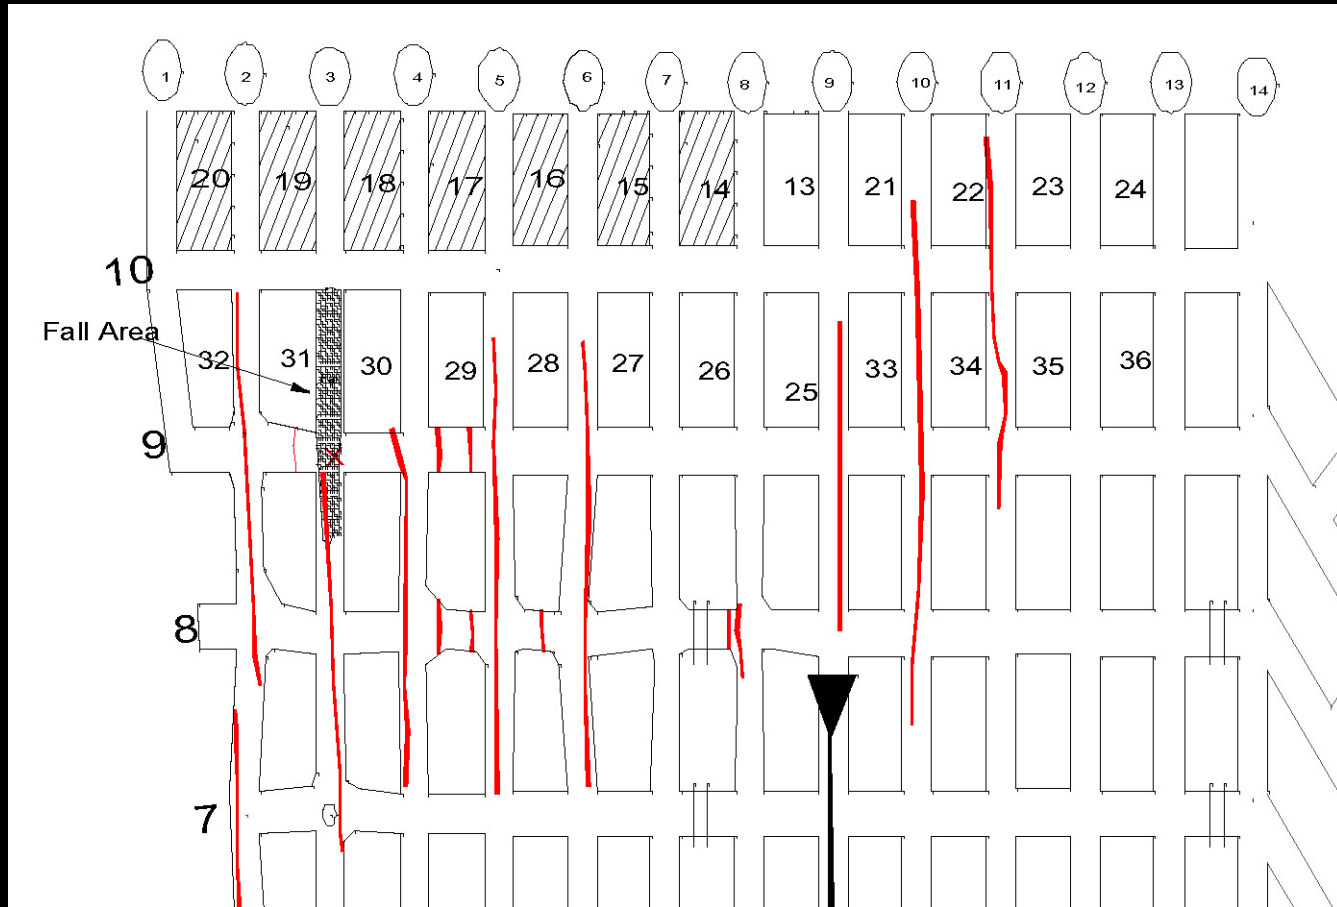
- The left side of the fall was bounded by a near vertical, weathered stress-relief joint, often referred to as a hillseam or surface crack.
- This joint was approximately 3 to 5 inches wide and had been in-filled with rock and soft, clay-like material. There was also considerable iron-oxide staining visible.

- The extensive joint resulted in a detached block, cantilevered from the opposite side pillar. Abutment pressures from second mining overloaded the cantilevered beam and caused the failure in conjunction with a fall that originated within the pillared area. This same joint continued outby the fall area for approximately 120 feet where it angled over a coal pillar.

- The right side of the fall broke along the outside bolt row in the entry, and while generally vertical, was more jagged than the smooth vertical surface on the weathered-joint side of the fall. The outby side of the fall was also somewhat jagged, and feathered out.

- Numerous other weathered joints were present throughout the section. Several of these were gapped as much as 5 inches. The joints typically ran North East.
